NANTICOKE RIVER BASIN

RECORDS POND DAM

PHASE I INSPECTION REPORT

NATIONAL DAM SAFETY PROGRAM

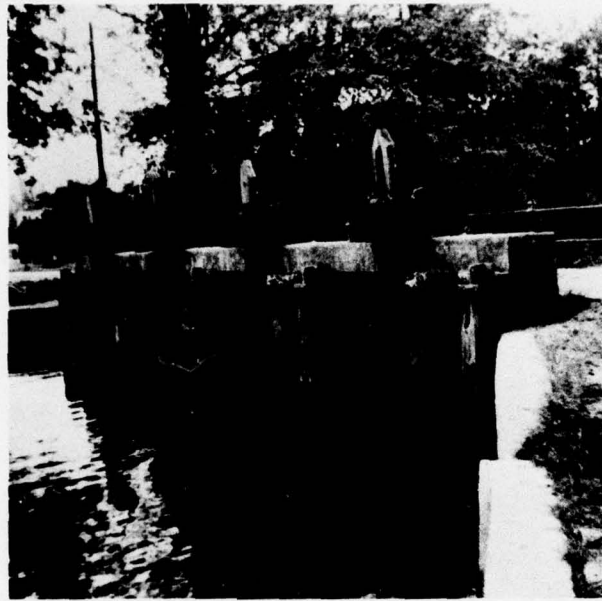
UPSTREAM FACE WITH GATES

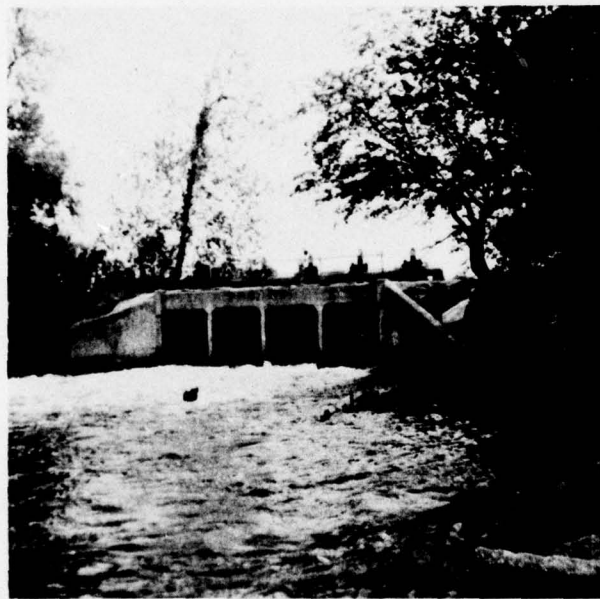
FOUR CELL BOX CULVERT DOWNSTREAM VIEW

2. Bridge/Box Culverts - Aggregate is exposed in the concrete but no serious cracking was observed. A full inspection of the timber gates was not possible since overflow was occurring but the hand operated controls and the timber gate stems were in satisfactory condition. Large trees are directly adjacent to the structure.

Large trees adjacent to the present abutments and wingwalls should be removed.

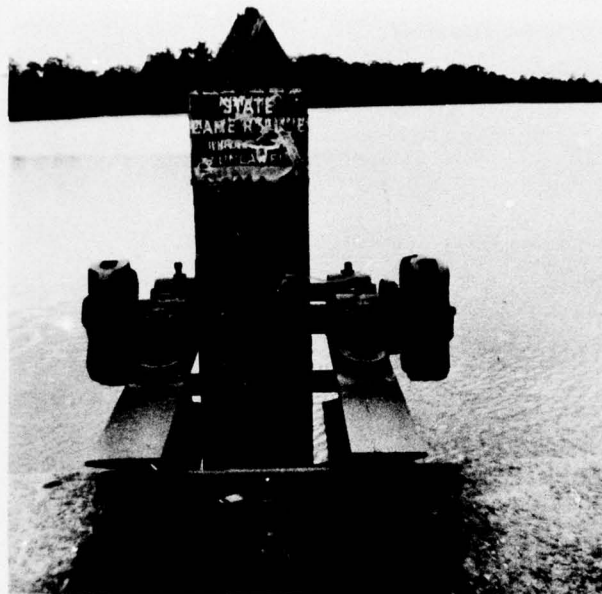
TYPICAL GATE CONTROL

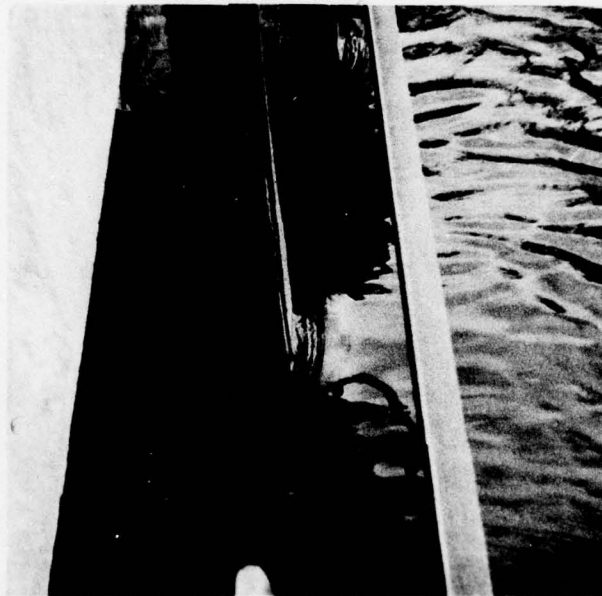
OVERFLOW AT TIME OF INSPECTION

VISUAL EXAMINATION OF	OBSERVATIONS	REMARKS OR RECOMMENDATIONS
CONCRETE SILL	No concrete sill spillway, water flows over four timber gates.	These gates were not observed, since six to ten inches of flow was occurring over them at the time of inspection.
APPROACH CHANNEL	No approach channel.	None.
DISCHARGE CHANNEL A-14	Well defined four cell box culvert in good condition, hydraulic jump occurs downstream.	None.
BRIDGE AND PIERS	Good condition.	None.
GATES AND OPERATION EQUIPMENT	Four hand operated timber gates mounted on timber stems operated in the event of rainfall, even minor rainfall.	Gates should be inspected in the raised position during low flow conditions.

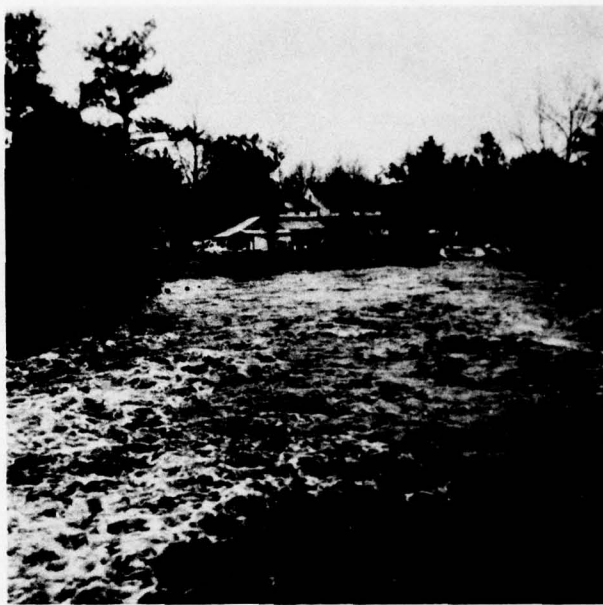
DOWNSTREAM RESIDENCES, LEFT BANK

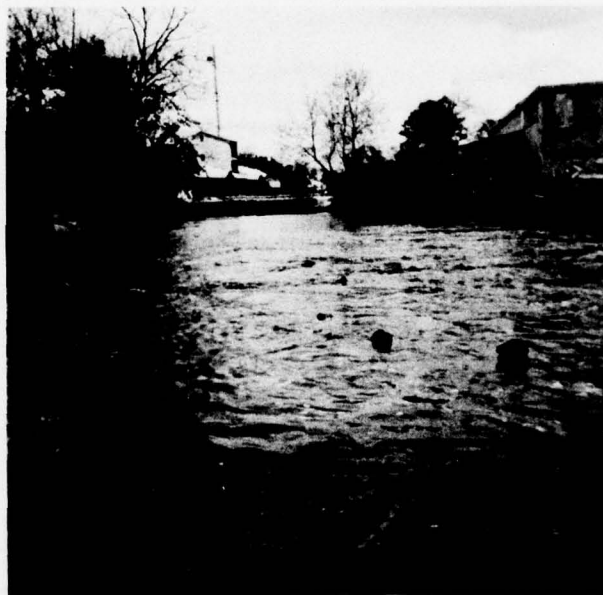
DOWNSTREAM BRIDGE AND INDUSTRIAL PROPERTY,
RIGHT BANK
